## Gage Drain and Pumping Station

#### **Board of Determination**

Buena Vista Community Center
December 6, 2016
6:30 PM

### Drain Inspection

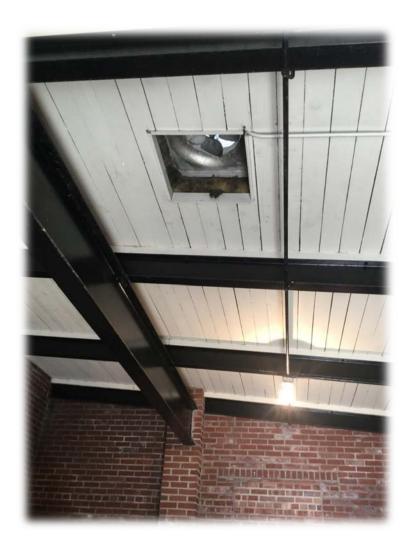
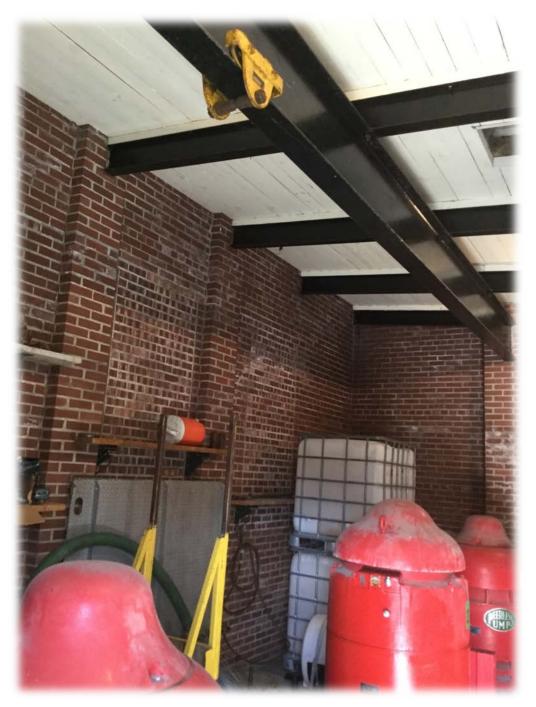
- Trash rack regularly breaks (chains are stretched & rusted)
- No. 3 pump is out of rotation. Bearings are worn way out of tolerance.
- Poor access to pumps roof is tongue & groove lumber with metal I-beams and a Duralast rubber roof.
- Past motor and starter failures

# Roof – No easy way to remove pumps

- Facility roof needs to be updated in order to be able to efficiently remove the pumps.
- The pumps have reached the end of their design life
- The trash rack has reached the end of its design life
- The overall facility is in need of safety improvements
- There is no backup power source
- The controls and the alarm equipment are outdated.
- Freeze prevention system needs to be updated to be more efficient (need to keep water inside of the pump from freezing to allow the pump to operate)

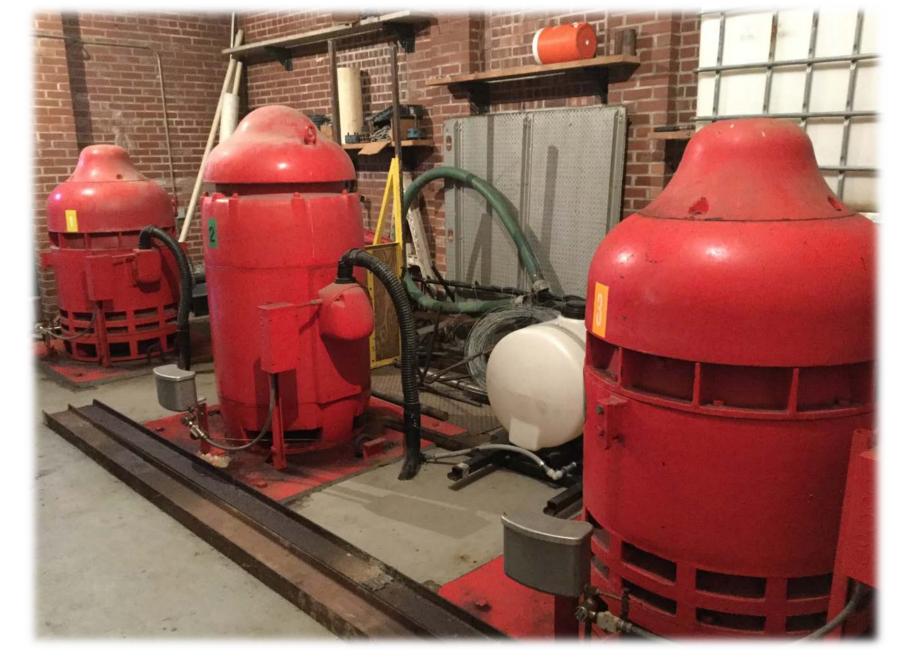
- Power Source
  - No Backup Power Source is available in case of an emergency
- Pumps
  - Pump Nos. 1 & 3 are approximately 68 years old. Age of Pump No. 2 is unknown, but it is a newer model than the others.
  - Pump Nos. 1 & 2 have approximately 9,500 hours, while Pump No. 3 has approximately 8,500 hours since 1983.
  - Recent problems include:
    - Pump number 3 was taken out of circulation in 2014 due to excessive bearings wear

Pumps 1 & 3 are original. Pump 2 is newer model.

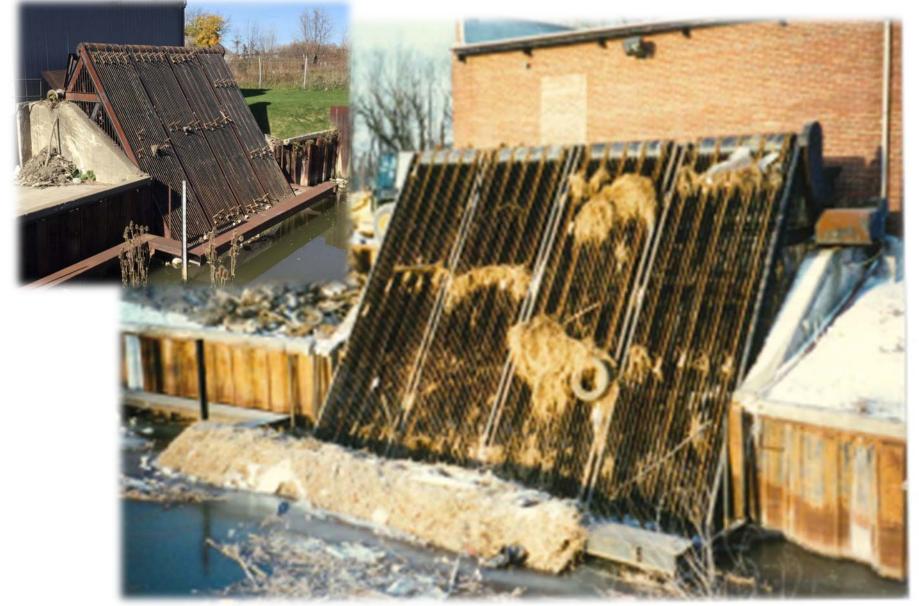
Trash Rack – Installed 1985

- Trash Rack (approximately 31 years old)
  - Existing trash rack is in poor condition
    - $\blacksquare$  Only 2/3 of cleaning mechanism functions properly
    - Excessive rusting and corrosion
    - Frequent breakage and failure
    - Difficult to repair due to very limited availability of replacement parts due to age
    - Frequently requires manual cleaning due to poor operation
    - No lifting device is present to aid in the removal of large debris
    - Requires manual operation

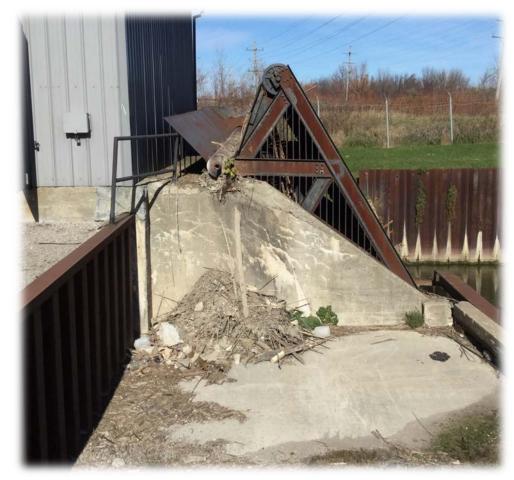
Trash Rack: Debris Pit
Costly to remove debris. Trash must
be separated, loaded into a dump
truck, and hauled away.

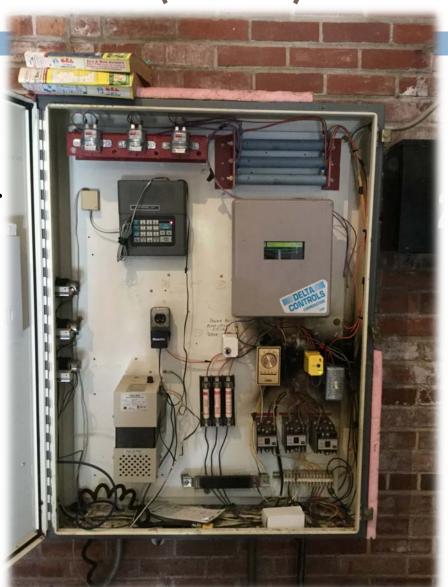
Existing pump controlsare automated but outdated.

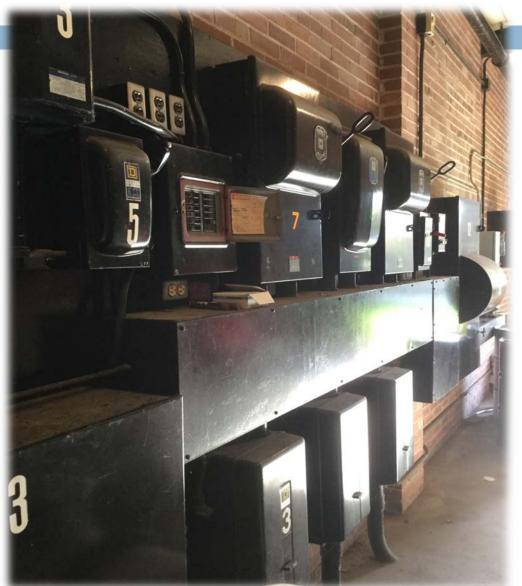
Existing switch gear controls are original.(Also called Pump Starters)

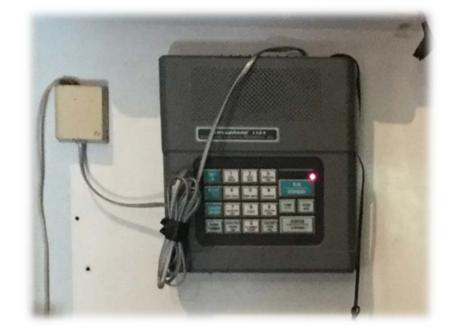
Pump Station has auto-dialer to alert operator when power goes out

No remote monitoring capabilities of equipment are

installed

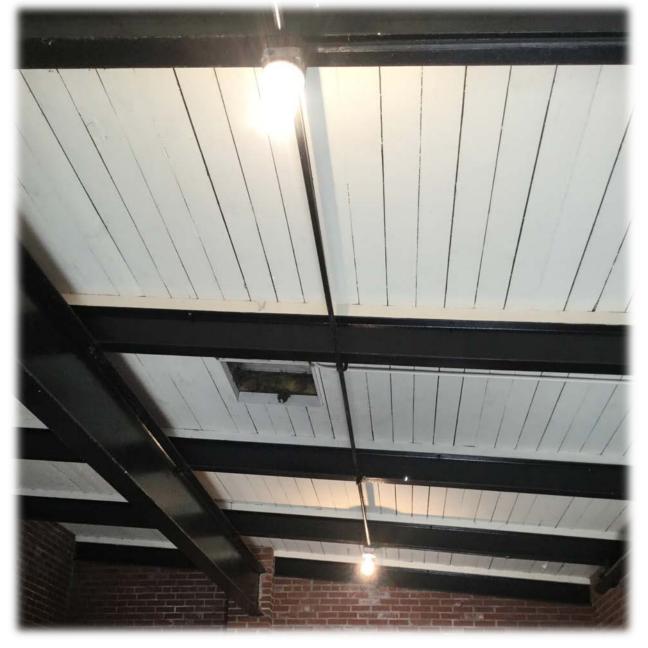
- Site Lighting and Safety
  - Safety in and around pump station needs to be brought up to today's standards (vs 1950's standards).
  - Existing lighting does not meet current standards and presents potential safety risk to operators
  - Fall prevention system not present on trash rack
    - No hand railing along cat walk in front
    - No hand railing along headwalls
  - Ventilation system is not operating as originally intended
  - No railings/permanent ladder present on roof for use during pump removal operations

Pump Station Interior Lighting

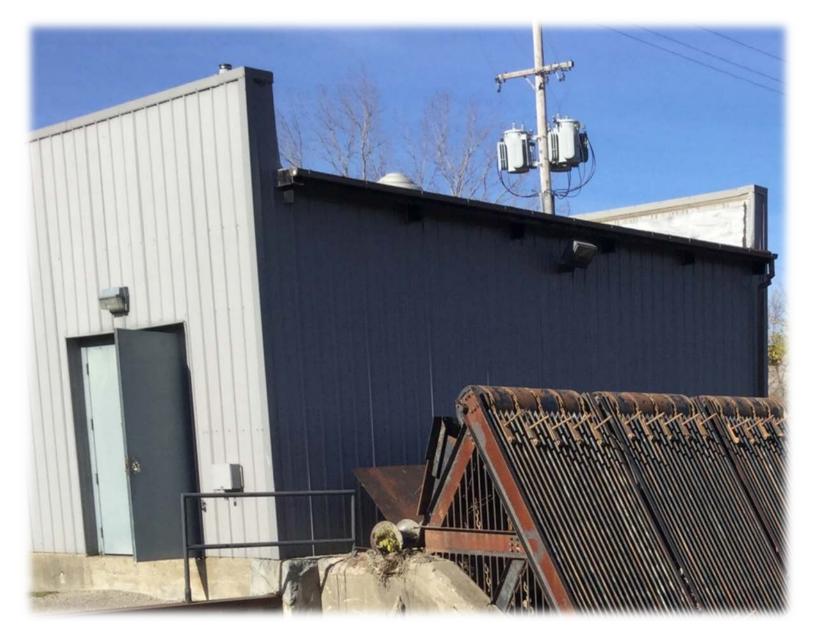
Pump Station Exterior Lighting

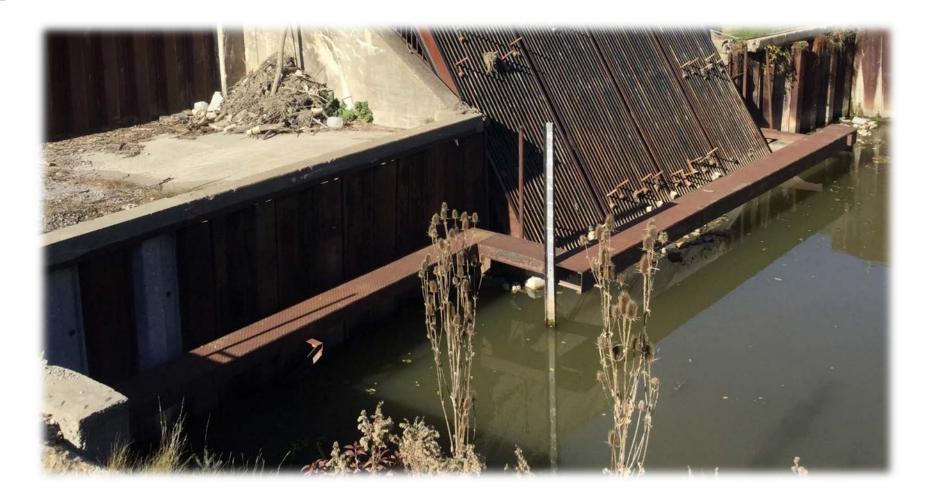
No Fall Prevention System at Trash Rack

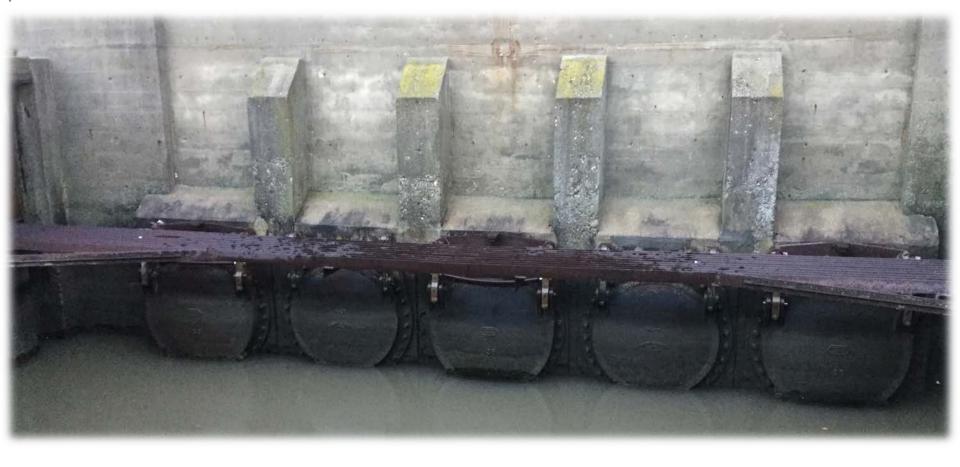
No Fall Prevention System at Discharge Pipes

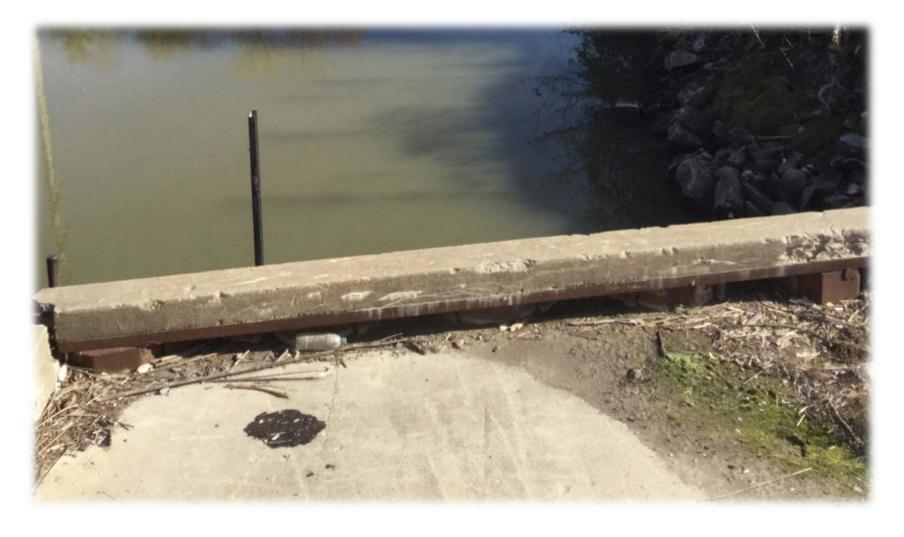
Trash Pit: Damaged Concrete

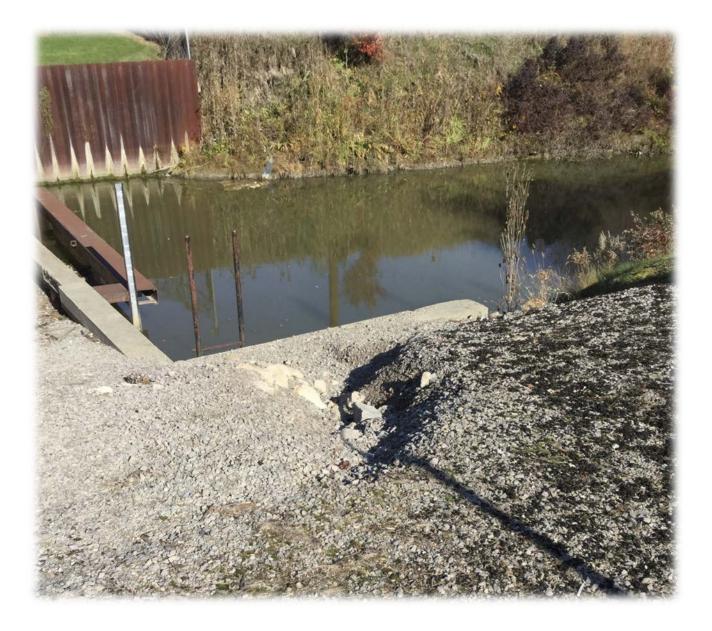
Soil Erosion Near Trash Pit

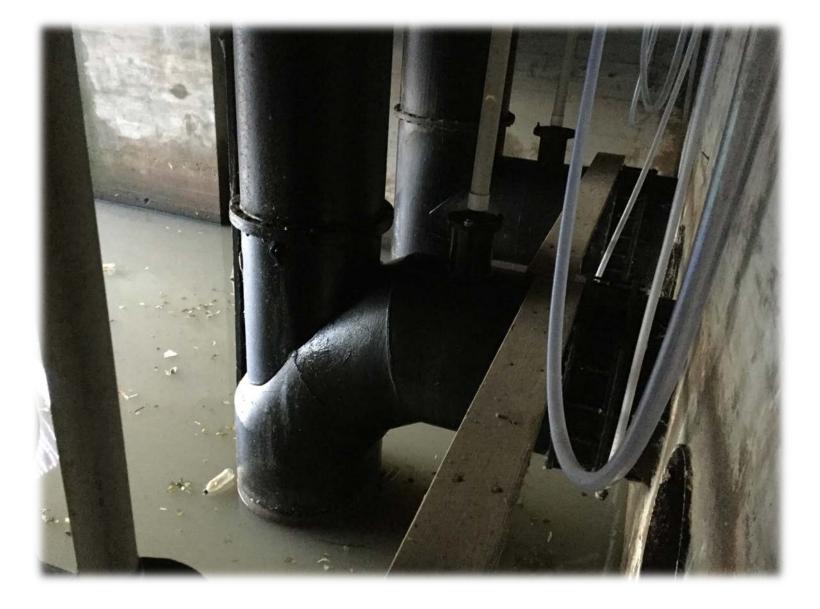
Wet Well – Problems with pumps freezing, confined space entry required to access, and no safety railings
